## **Vibration Technical Data Report**

Broadway Subway Project  
Ministry of Transportation and  
Infrastructure

Stantec Consulting Ltd.

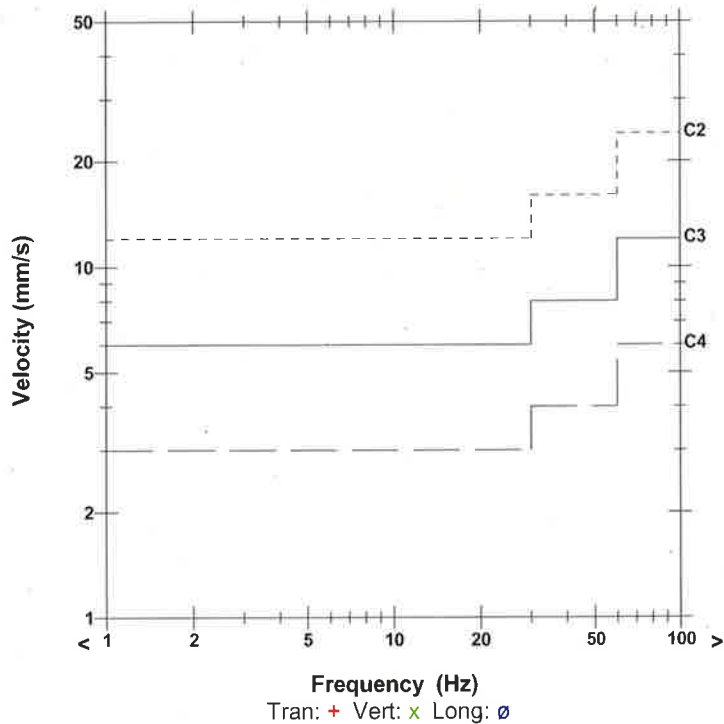
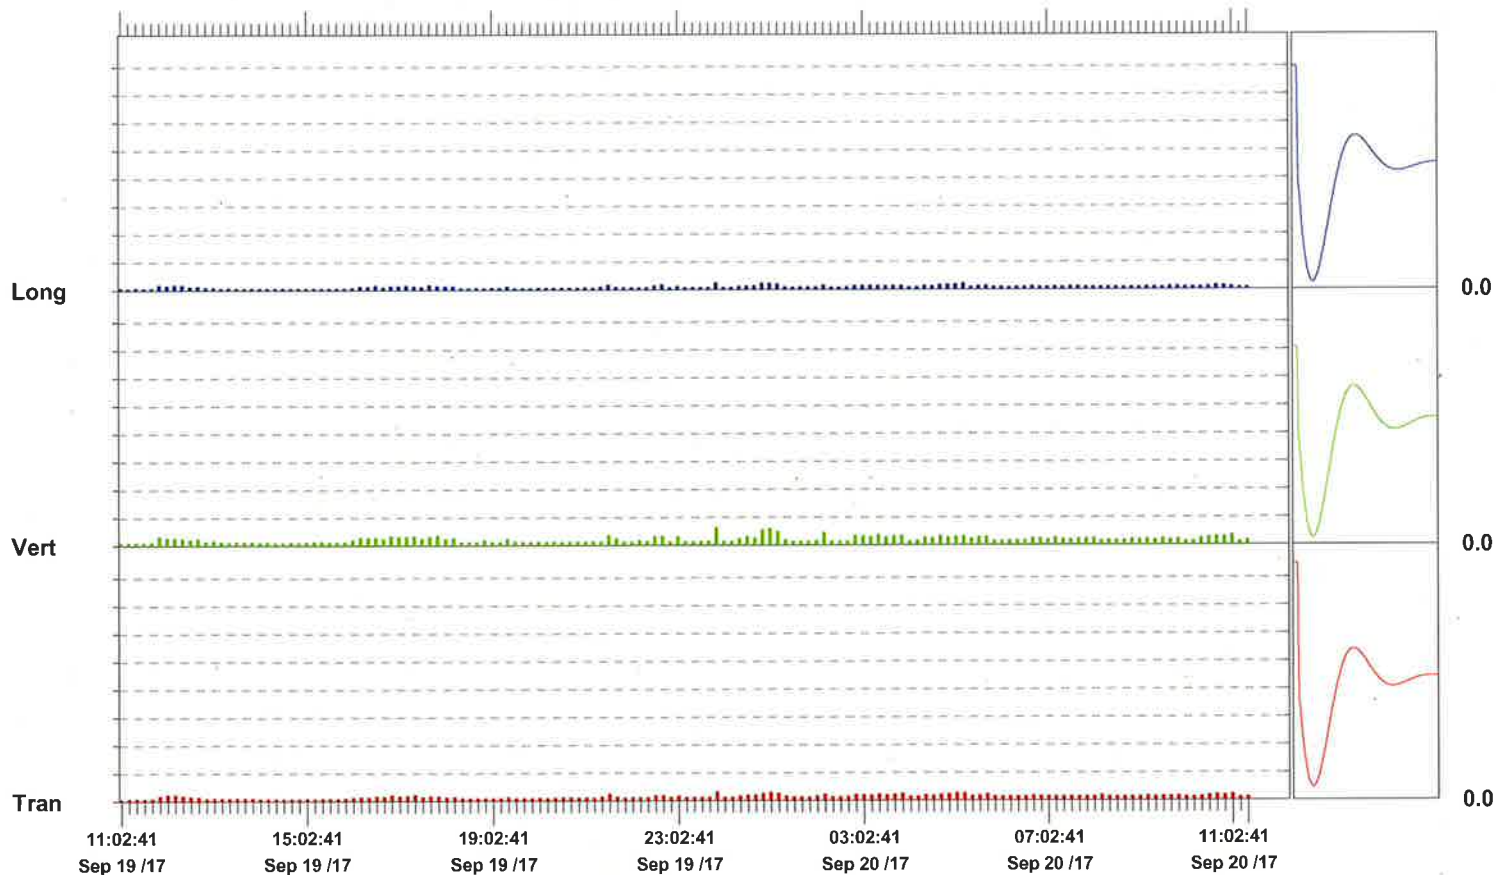
**Histogram Start Time** 11:51:01 September 20, 2017  
**Histogram Finish Time** 12:53:57 September 21, 2017  
**Number of Intervals** 6011.73 at 15 seconds  
**Range** Geo:254.0 mm/s  
**Sample Rate** 2048sps  
**Job Number:** 4099  
**Operator/Setup:** Bryce Boldt/Bryce.MMB

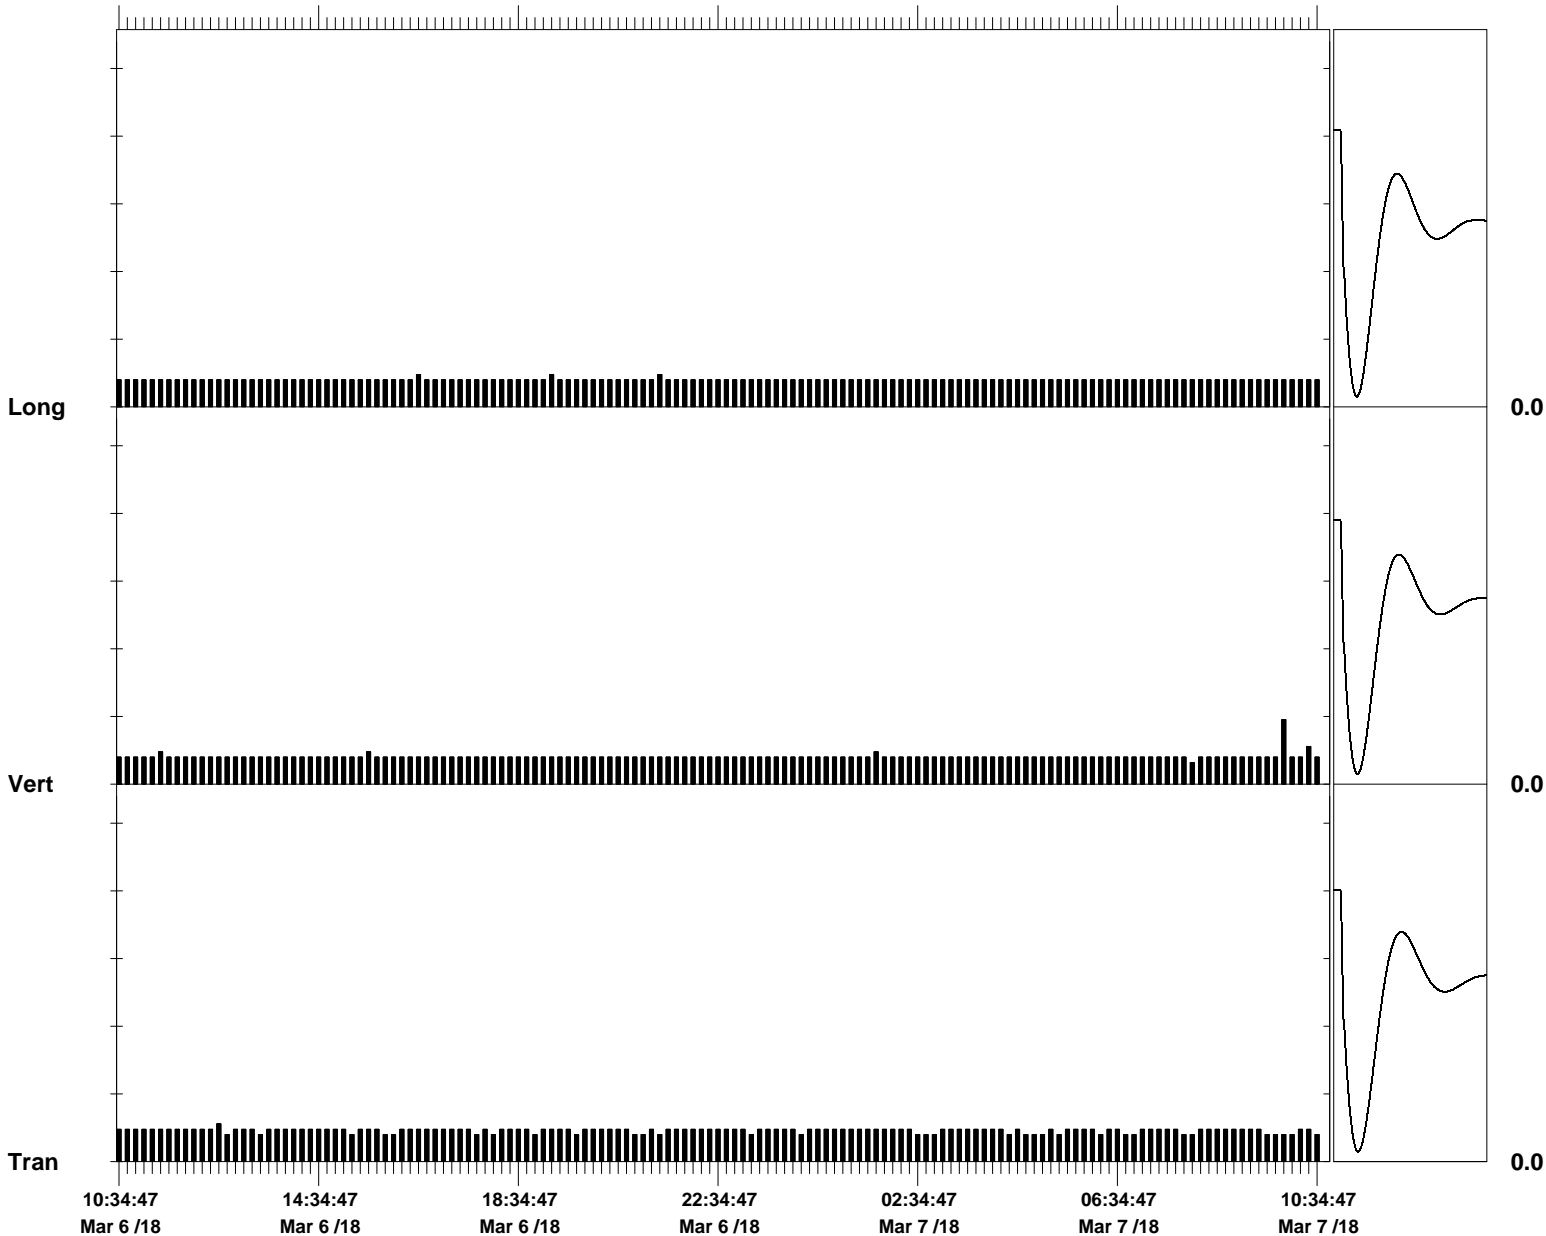
**Peak Vector Sum** 0.197 mm/s on March 7, 2018 at 09:54:17

**Time Scale:** 10 minutes /div **Amplitude Scale:**Geo: 0.200 mm/s/div
